ASSESSING INFRASTRUCTURE VULNERABILITY IN NATIONAL PARKS: WCU PROTOCOLS & PAST PROJECTS

*PROGRAM FOR THE STUDY OF DEVELOPED SHORELINES
WESTERN CAROLINA UNIVERSITY*

ROB YOUNG, PHD, PG

WCU Coastal Hazards & SLR Asset Vulnerability Assessment Protocol

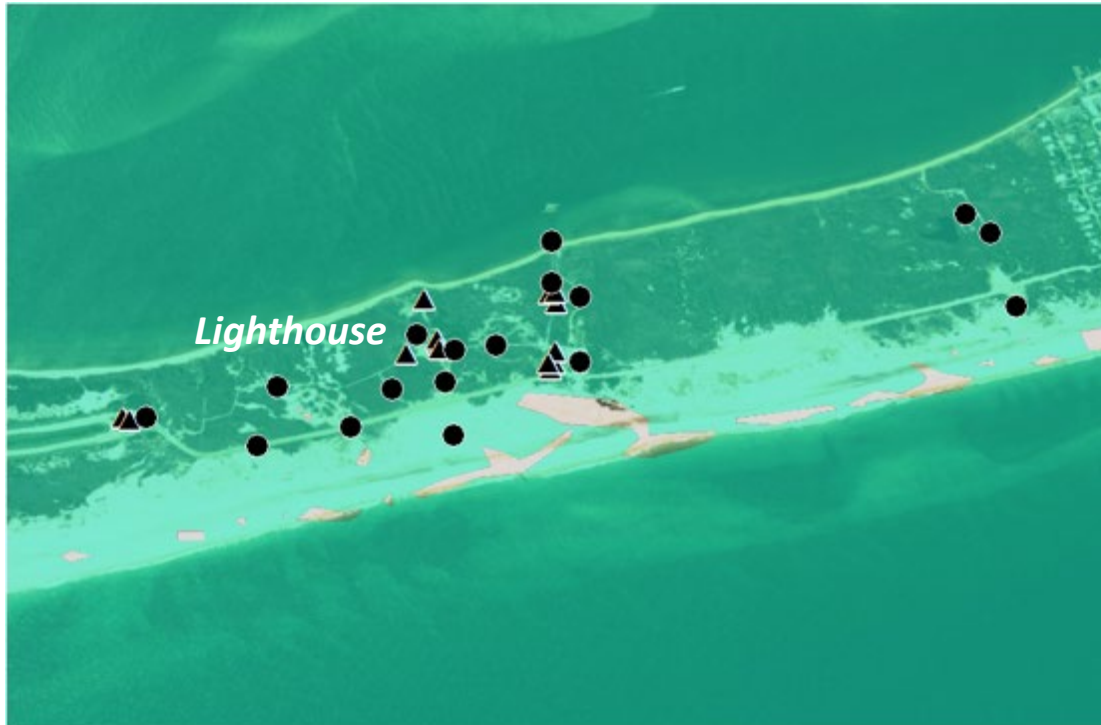
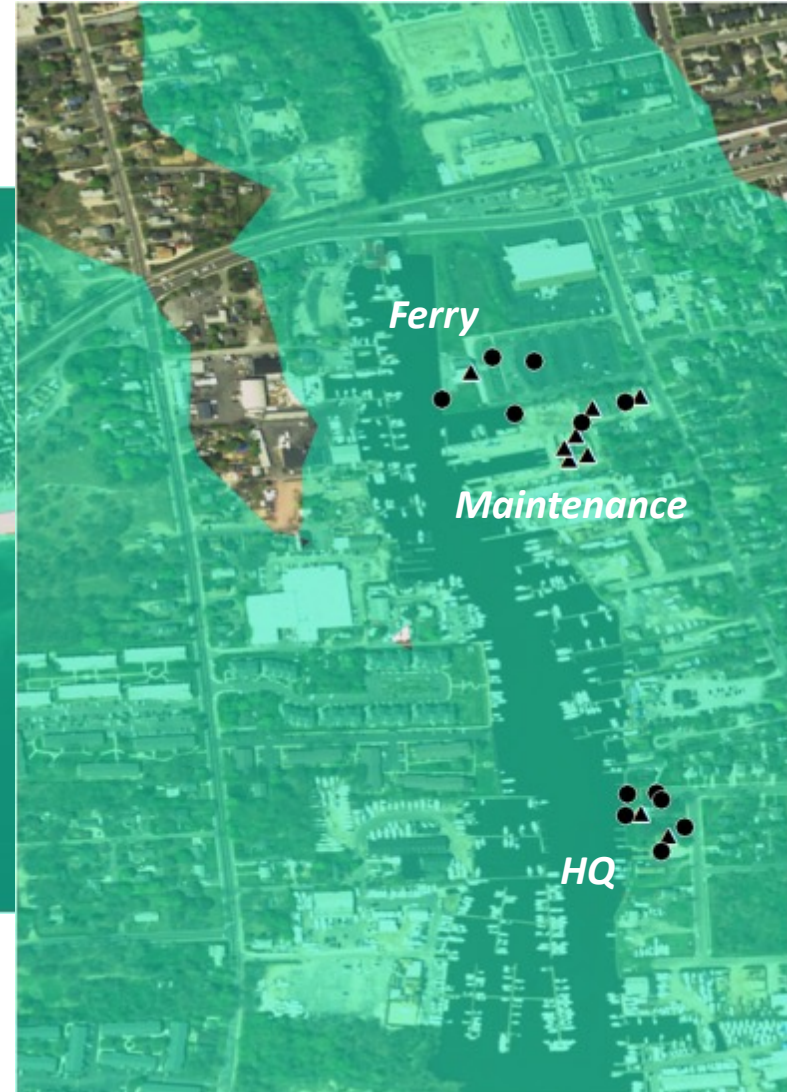
EXTREME EVENT FLOODING INDICATOR DATA

Data:
Storm Surge Cat 3 SLOSH Model

Data Source: NPS CCRP
